# Manhole Inspection Summary

Manhole # S06YY1003MH

Insp Date: **6/21/06 8:00 AM**

**Location** Address: **3924 CLARINTH AVE**

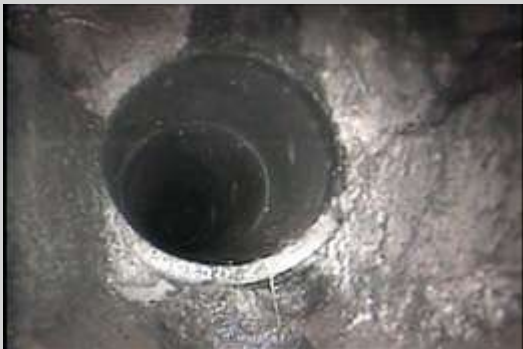
### 6 in. Circular Gravity Sewer Pipe In @ 4 O'Clock

Pipe Material: **Clay** ☐ Pipe Lined

Infiltration: **None** Pipe Seal Cond: **Unknown**
